ACTION MOBIL

PDF
JOURNAL 2/2017

Trip Report Part 3

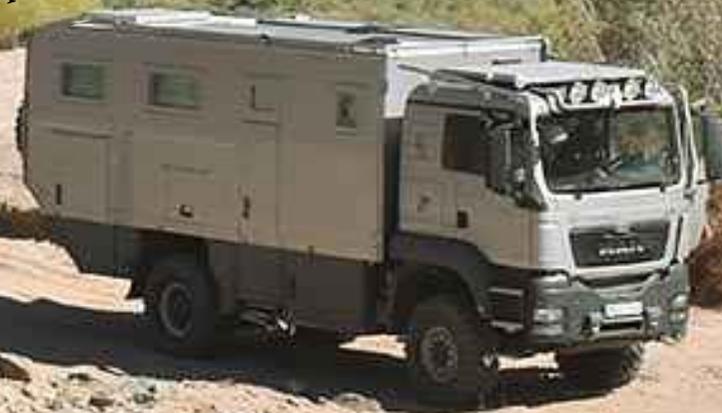
The tested ACTION MOBIL shown in the photo is equipped with additional shock absorbers on the front axle. Vibration dampers in the auxiliary frame and a modified driver cabin suspension. The interior design of the accommodation cabin is luxurious. Apart from some scratches on its body, the ACTION MOBIL has reached its destination safely.

A lot of today's driving comfort needs to be adapted to the requirements of the terrain and theory is not enough in most cases. Again and again, test trips are necessary. Additional shock absorbers on the front axle, vibration damping in the area of the auxiliary frame and different intermediate frame constructions have been tried out in test drives and have optimised the off-road behaviour substantially. Expert counselling is the basis of the individually adapted, final result: an ACTION MOBIL, which makes adventure a pleasure!
